Summary of Loss Report

26-00006-WTR

4061 East Melody Drive Gilbert, AZ 85234

Kitchen - Hot water supply line leak in wall behind cabinet and intruded down to the basement below.

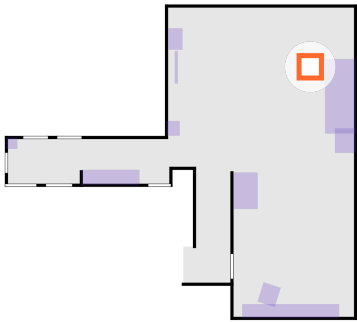
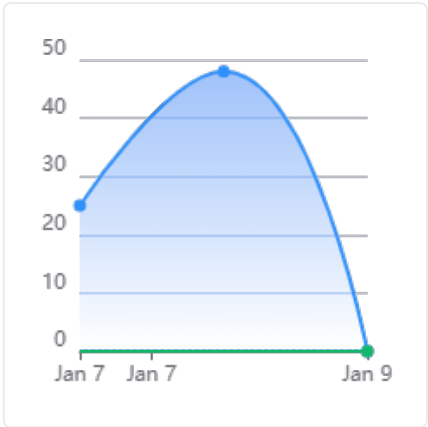
Floor Point - 2

Material  
Vinyl, Laminate

✔ Marked dry on 01/09/2026 03:22 PM

| | 01/07 | 01/08 | 01/09 |
|---|---|---|---|
| Affected | 25.0% | 48.0% | - |

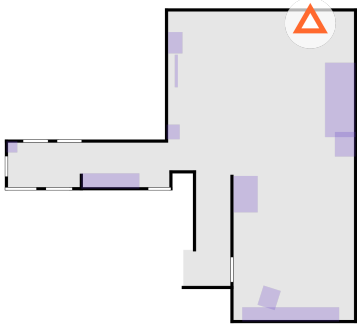
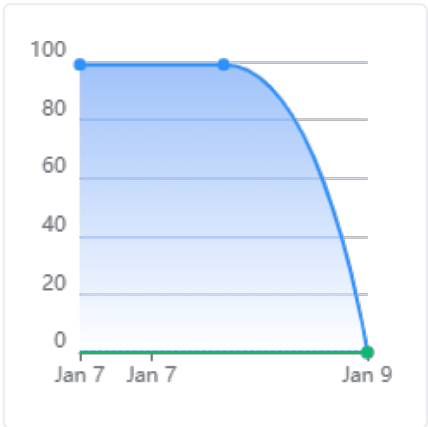
Ceiling Point - 1

Material  
Drywall

✔ Marked dry on 01/09/2026 03:23 PM

| | 01/07 | 01/08 | 01/09 |
|---|---|---|---|
| Affected | 99.0% | 99.0% | - |

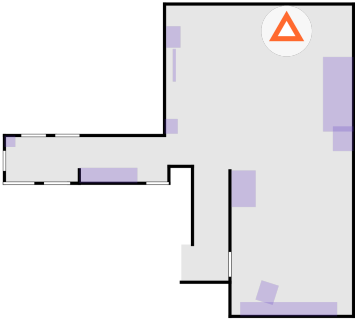
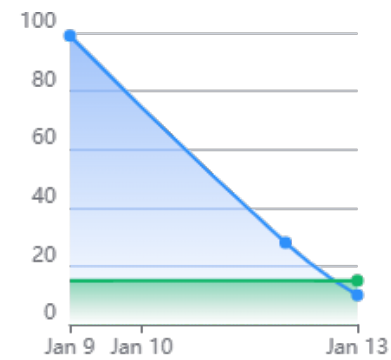
Ceiling Point - 3

Material  
Wood

✔ Marked dry on 01/13/2026 12:18 PM

Dry goal  
15.0

| | 01/09 | 01/12 | 01/13 |
|---|---|---|---|
| Affected | 99.0% | 28.0% | 10.0% |

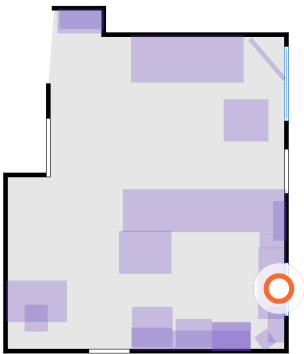
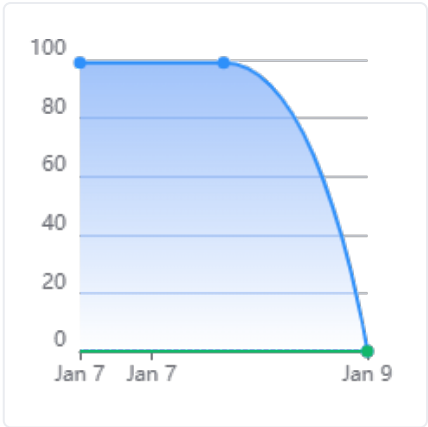
Wall Point - 1

Material  
Drywall

Marked dry on 01/09/2026 03:27 PM

| | 01/07 | 01/08 | 01/09 |
|---|---|---|---|
| Affected | 99.0% | 99.0% | - |

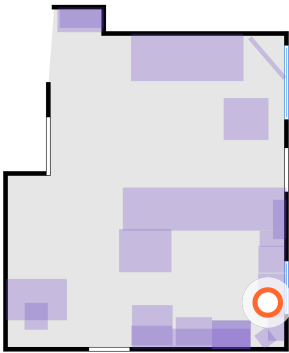
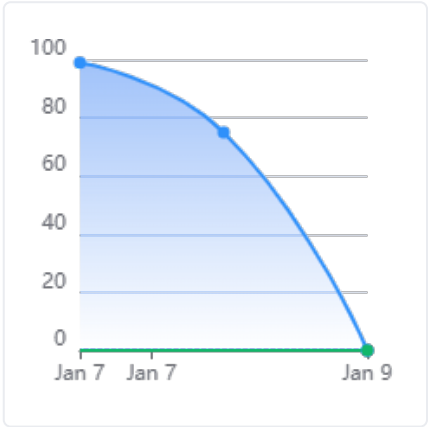
Wall Point - 2

Material  
Hardwood, Drywall

Marked dry on 01/09/2026 03:26 PM

| | 01/07 | 01/08 | 01/09 |
|---|---|---|---|
| Affected | 99.0% | 75.0% | - |

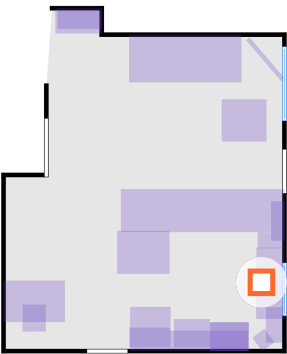
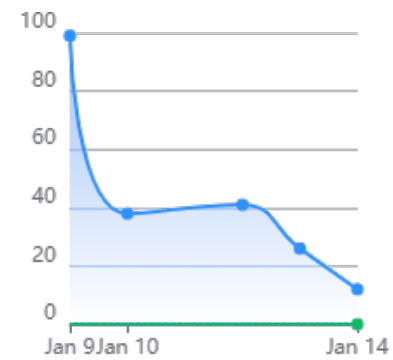
Floor Point - 3

Material  
Wood Sill Plate

✔ Marked dry on 01/14/2026 02:11 PM

| | 01/09 | 01/10 | 01/12 | 01/13 | 01/14 |
|---|---|---|---|---|---|
| Affected | 99.0% | 38.0% | 41.0% | 26.0% | 12.0% |
